IMPACT RESISTANCE OF COMPOSITE FAN BLADES

GENERAL ELECTRIC COMPANY
AIRCRAFT ENGINE GROUP
Cincinnati, Ohio 45215

**NATIONAL AERONAUTICS AND SPACE ADMINISTRATION
NASA-LEWIS RESEARCH CENTER**

Contract NAS3-16777

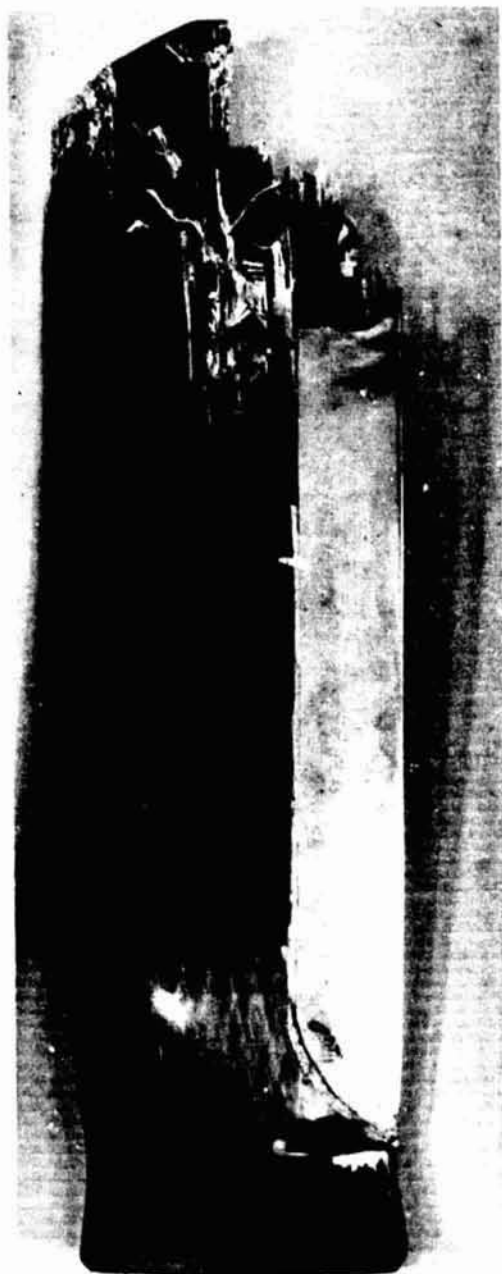
Figure 59. Blade S/N H/E3 After Impact.

NASA-FOD Program
Blade S/N H/E3
Design No. 2 Material
Real Mallard Duck
Bird Size: 1134 g (40 oz)
Slice Size: 680 g (24 oz)
Blade Tip Speed: 244 m/sec (800 ft/sec)
Incidence Angle: 0.384 Radians (22°)

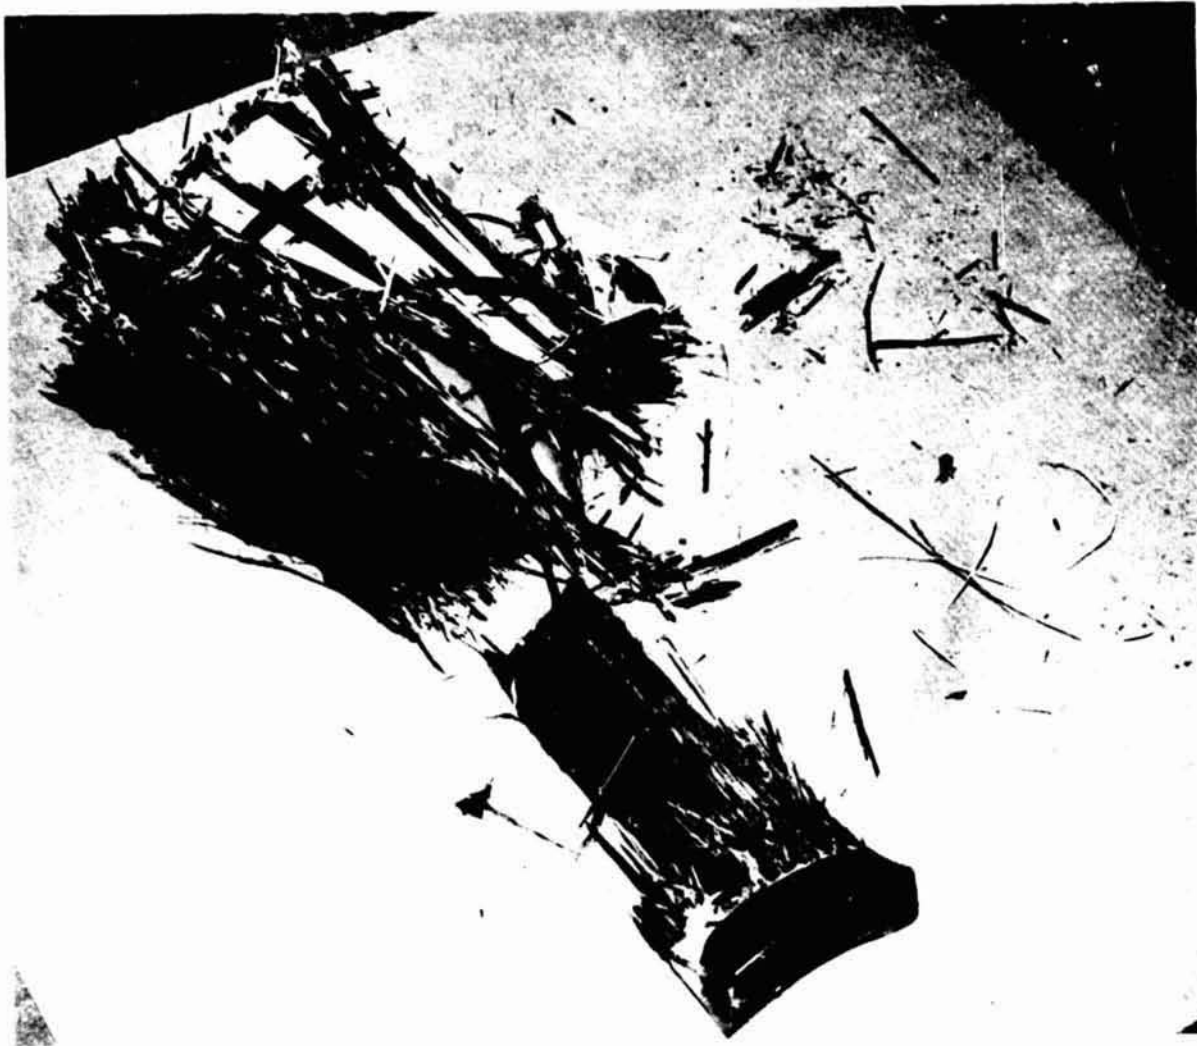
Figure 61. Blade S/N H/E5 After Impact.

NASA-FOD Program
Blade S/N H/E5
Design No. 1 Material
RTV Simulated Bird
Bird Size: 1360 g (48 oz)
Slice Size: 765 g (27 oz)
Blade Tip Speed: 244 m/sec (800 ft/sec)
Incidence Angle: 0.384 Radians (22°)

S/N H/E 5, H/E 6 - Both H/E 5 and H/E 6 sustained 100% delamination after impact with 765 g (27-oz) and 567 g (20-oz) slices of birds, respectively. H/E 5 broke off at the root, while H/E 6 remained in one piece. Figure 67 shows these blades prior to test.
